Hydrant Protection Pty Ltd

PRODUCT APPRAISAL REPORT 1730 Issue 3

Hydraguard and Retroguard Ant Barrier Devices for Hydrants

Issue 3 Published: 17 March 2023

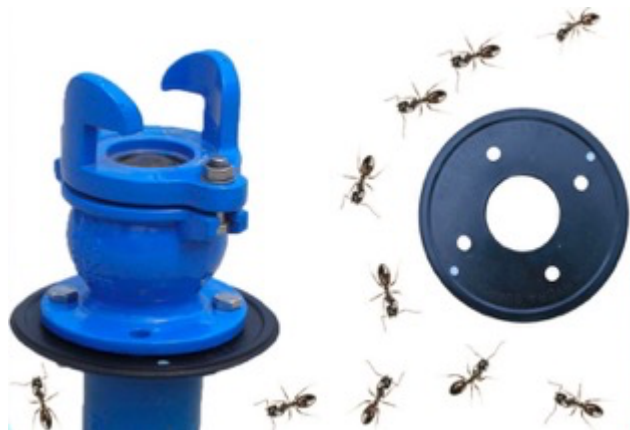
FIGURE 1 HYDRAGUARD INSTALLED

Hydraguard is a circular plate with an elastomeric seal located around its rim. The plate has 4 bolt holes and two capillary drainage plugs incorporated into the plate. The Hydraguard is installed between the flanges of a hydrant and riser during installation. See Figure 1.

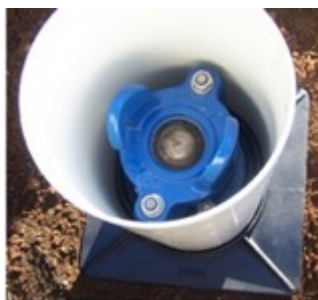
FIGURE 2 SHROUD PIPE INSTALLED

A DN 225 PVC PN4 shroud pipe is installed over the assembly and a seal is formed between the elastomeric seal located on the rim of the Hydraguard plate and the inside of the PVC shroud pipe. This provides an effective barrier to ant mobility. See Figure 2.

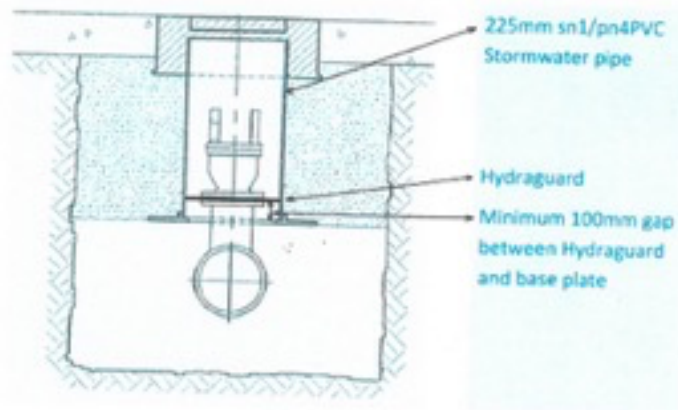
FIGURE 3 COMPLETED HYDRAGUARD ASSEMBLY

The complete installation assembly is shown in Figure 3.

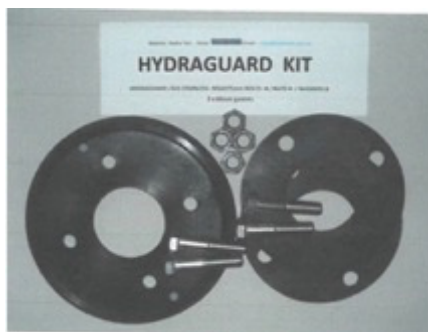
FIGURE 4 HYDRAGUARD KIT

Hydraguard is available to suit DN 80 or DN 100 hydrants with either circular or square shapes. The Hydraguard kits are supplied with two 3mm solid EPDM flange gaskets and four M16 x 75 Grade 316 stainless steel bolts and nuts. See Figure 4. Other components including the base plate, shroud pipe and hydrant box are not included in the kit.

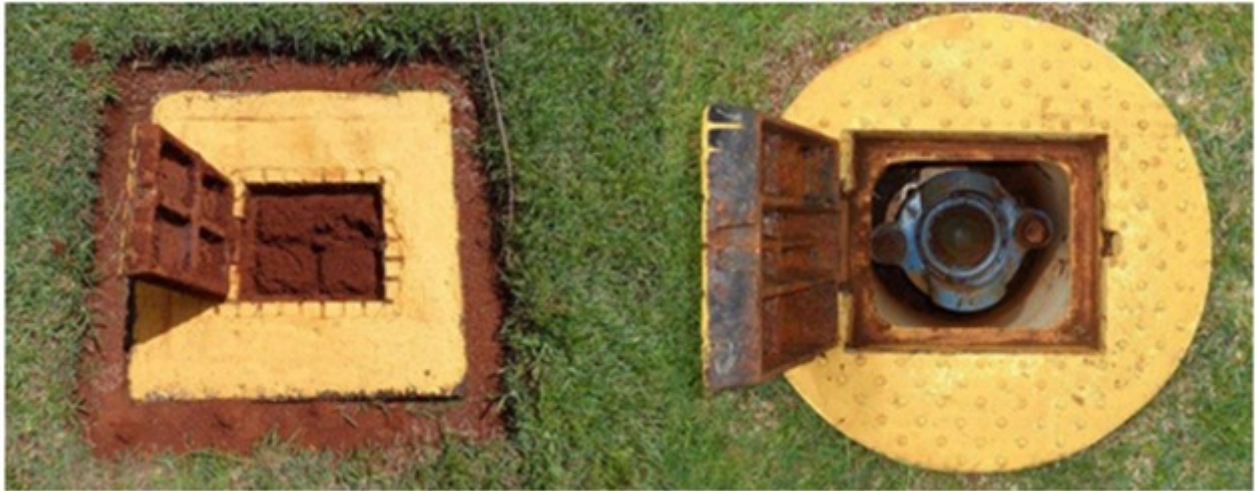
FIGURE 6 HYDRAGUARD EFFECTIVENESS

The photographs of two hydrants located 60 metres apart, shown in Figure 6, indicate the effectiveness of Hydraguard. The hydrant on the right had Hydraguard installed five years ago whilst the hydrant on the left has been subjected to routine maintenance.

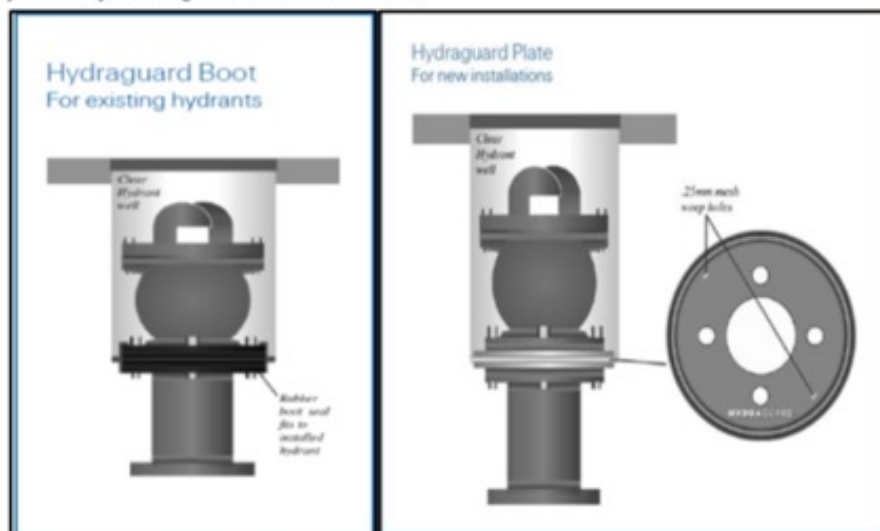
- Hydraguard boot- retrofits to the existing hydrant flange, easy to install without shutting down the water mains,
- Hydraguard disc/plate for new installations- disc is installed between the hydrant and spool flange at time of installation. This type of disc can also be installed as an alternative to the boot on older hydrants by shutting down the water mains.

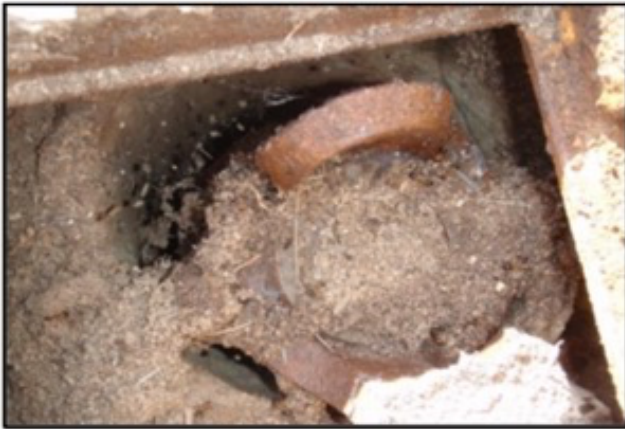
Figure 1: Ants infested hydrant

A series of time lapse photos for one of the hydrant from the trial are shown below.

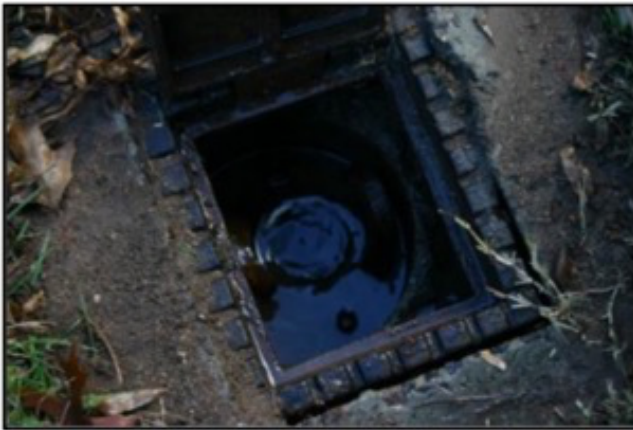
Figure 2: Ants infested hydrant after being cleaned with high pressure hydro digger

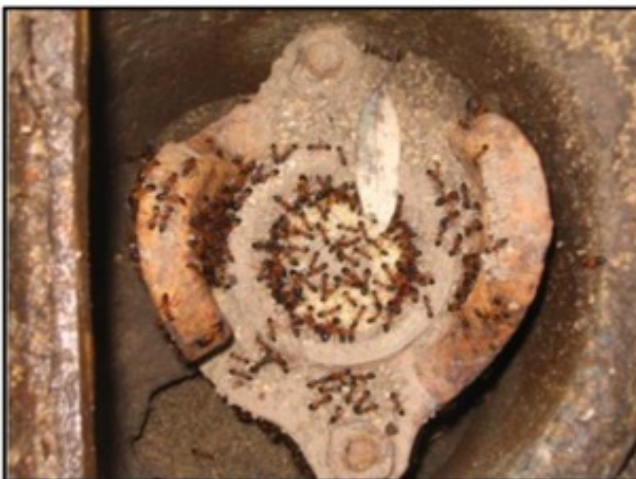
Figure 3: Ants infested hydrant with reappearance of ants 3 weeks after cleaning

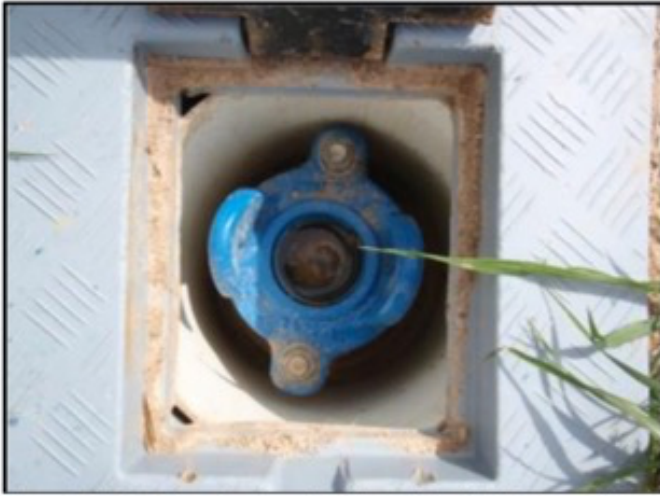
Figure 4: Hydrant head replaced and installed with hydraguard boot (March 2011)

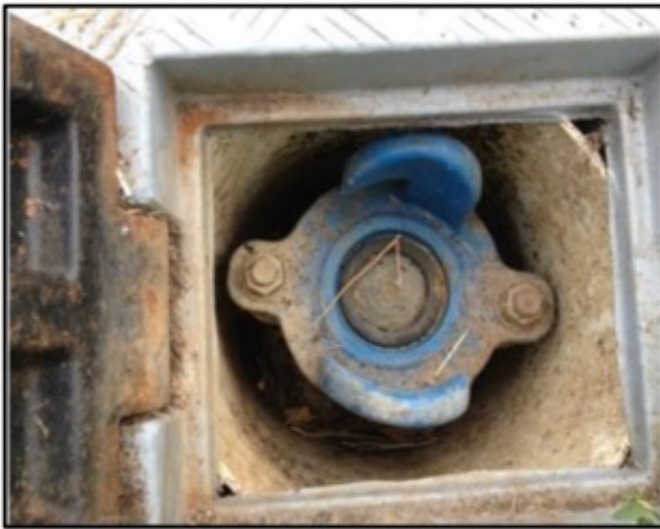
Figure 5: Hydrant monitored in Dec 2012

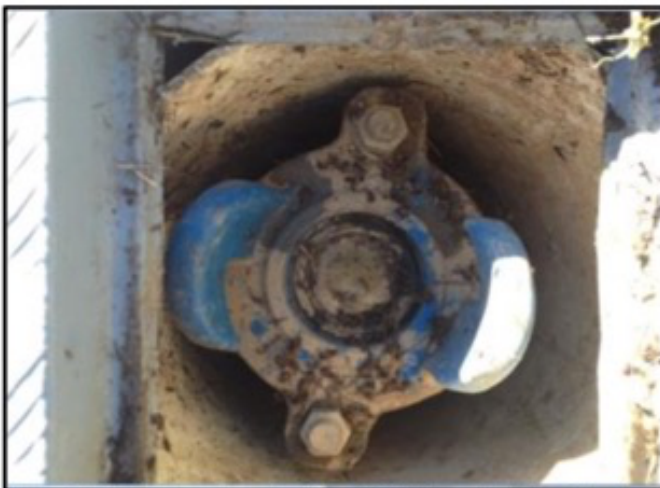
Figure 6: Hydrant monitored in July 2013 (Ants noticed but dead)

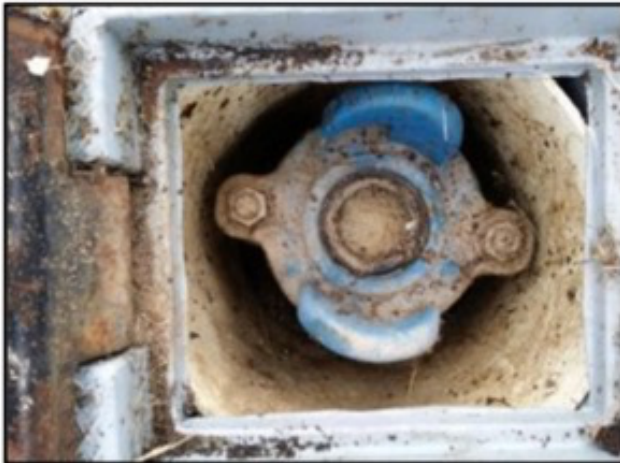
Figure 7: Hydrant monitored in May 2014(No ants)

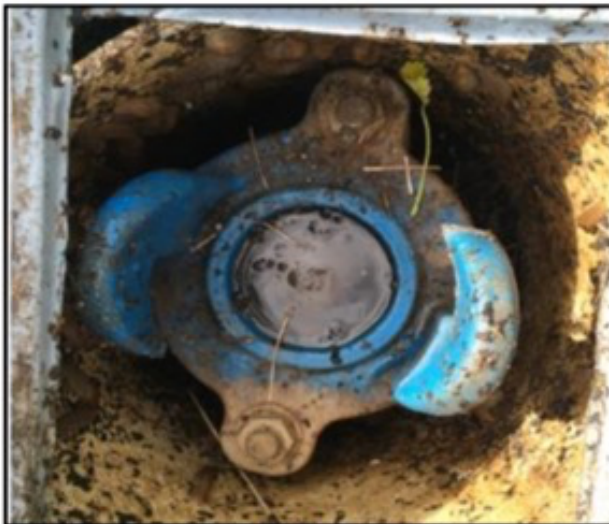
Figure 8: Hydrant monitored in April 2015(No ants)

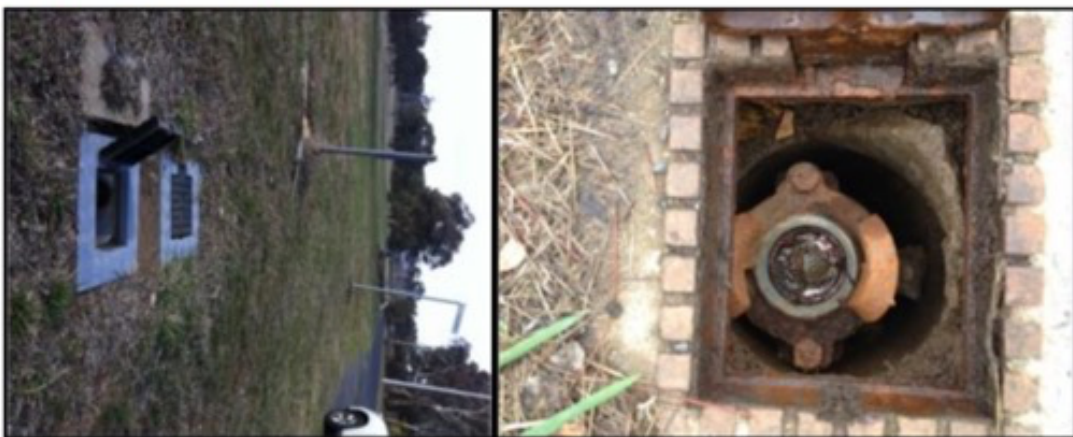
Figure 9: Hydrants monitored for ants migration (3 hydrants 2 together and 3rd one at a 10m distance with no hydraguard boot and no problem with ants. No migration of ants from one hydrant to another).

Another important question that was raised during the trial phase was to monitor if the ant nests are destroyed in one hydrant, do the ants find their way to an adjacent hydrant to make a nest? To verify this, three hydrants were identified close to Icon Water Depot. Two ant prone hydrants were within a meter apart and had hydraguard boots installed while a third one (was at 10m distance from the other two) without hydraguard boot and never had a history with ant nest.

These hydrants were monitored over time and it was found that while the ants had been removed from the first two hydrants by installing the boots, the ants had not reappeared in these two hydrants or migrated to the third hydrant. Further evidence to support this issue is being gathered.
