PRODUCT APPRAISAL REPORT 2036

Ant and Debris Barriers for Hydrants

Published: 14 October 2020

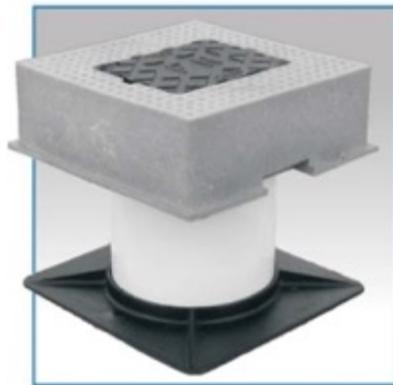
FIGURE 1

TYPICAL HYDRANT INSTALLATION ARRANGEMENT – NON-TRAFFICABLE

This appraisal considers ant and debris barriers for below ground spring hydrants. They are designed to suit hydrant installation arrangements commonly used within Queensland and NSW. See Figure 1.

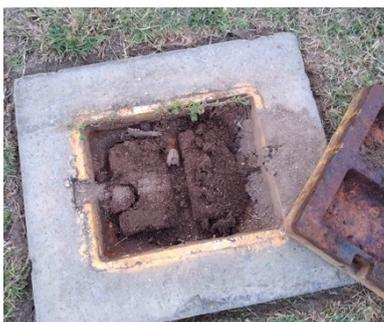
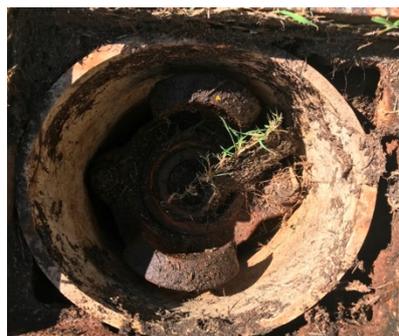
FIGURE 2

EXAMPLES OF ANT DEPOSITED SOIL AND DEBRIS IN HYDRANT CAVITIES

It is common for a hydrant box cavity, where below ground spring hydrants are located, to completely fill with soil transported by ants, often within a period of weeks. Debris can also enter the cavity through the surface access cover. See Figure 2 for examples.

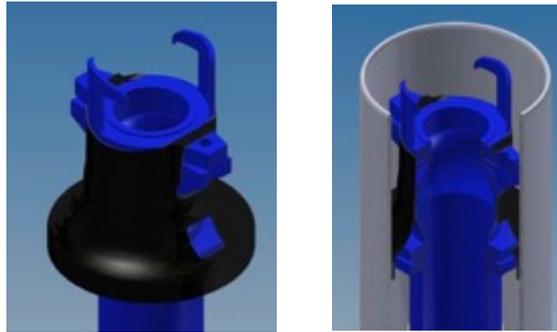
1. The bikini is fitted tightly around the hydrant body and adjacent hydrant riser flange joint whilst also providing a barrier around the inside of the PVC shroud pipe. This method is proposed to retrofit the barrier to existing hydrants or for fitment during replacement of a hydrant. This option utilises a bikini with pre-cut holes to facilitate exposure of the body-lug connection bolts. See Figure 3.

FIGURE 3 BIKINI FITTED TO HYDRANT

The base of both bikini pieces incorporates a specially shaped PVC ring to act as a spring to provide sufficient sealing pressure on the inside of the PVC shroud pipe. Polyethylene mesh drain holes are also incorporated to allow water drainage whilst preventing ant access.

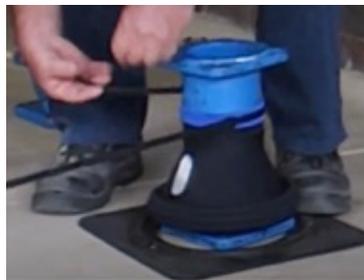
2. The bikini is fitted to the hydrant riser below the hydrant and sealed using a zip tie whilst also providing a barrier around the inside of the PVC shroud pipe. This method is generally used for new installations. This option utilises a bikini similar to option 1 except that it has no pre-cut holes and incorporates belt loops to facilitate fitment of a plastic zip tie. See Figure 4.

FIGURE 4 BIKINI FITTED TO HYDRANT RISER

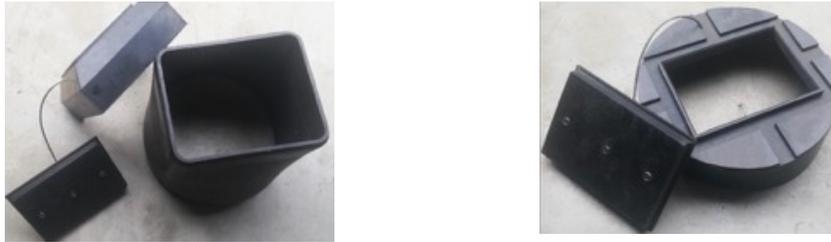
An option to install an inner cover and lid, manufactured from nitrile rubber or polyethylene, is also available to provide a debris barrier, preventing entry of debris through the ground level access cover. Options are available to accommodate either trafficable DI access covers or non-trafficable plastic access covers. See Figure 5.

**FIGURE 5****TRAFFICABLE AND NON-TRAFFICABLE NITRILE OR PE INNER COVER AND LID****4 SCOPE OF THE APPRAISAL**

The inner cover and lid are manufactured from Nitrile rubber with nominal 70 durometer hardness or polyethylene. The lid is attached to the cover using a stainless-steel cable.

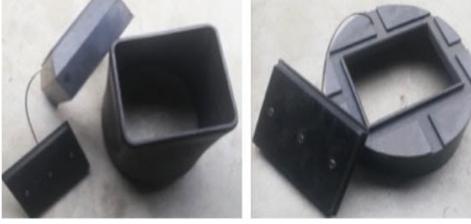
Trafficable or Non-Trafficable Debris barrier
(Determined by Box Type)

Trafficable Style Box
for this type

Non-trafficable Style
Box for this type

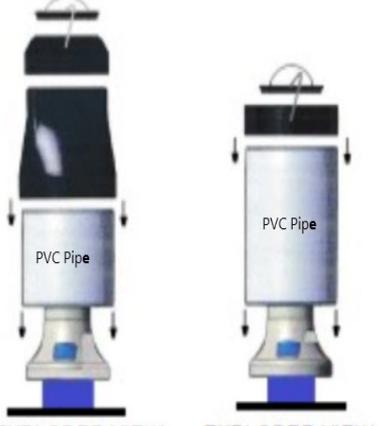
EXPLODED VIEW
TRAFFICABLE

EXPLODED VIEW
NON-TRAFFICABLE

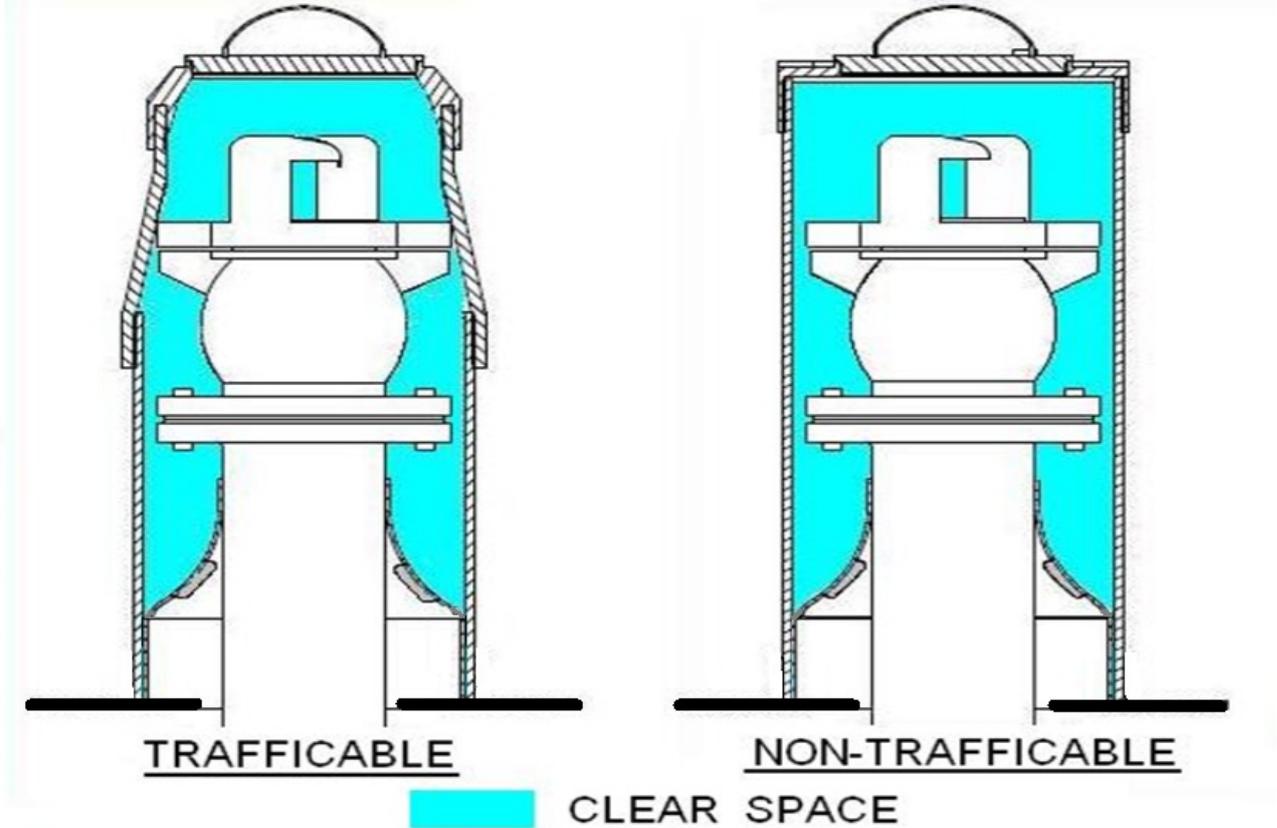
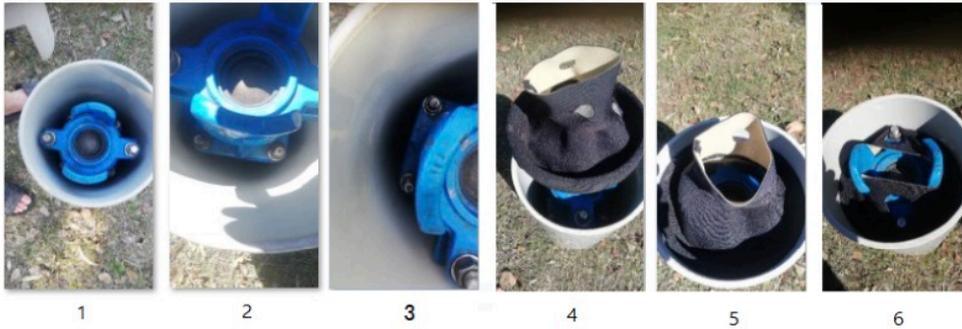
ANT AND DEBRIS BARRIER - INSTALLATION INSTRUCTIONS

RETROFIT TO EXISTING HYDRANT USING BIKINI WITH PRE-CUT HOLES

- 1 Remove the surface cover to expose the DN 225 PVC shroud pipe.
- 2 Clear dirt and debris to a depth of 100mm below the level of the lug bolts.
- 3 Line up the pre-cut holes in the bikini with the lug bolts. Push the bikini piece over the lugs one side at a time to expose the lugs and bolts through the pre-cut holes. Push the bottom of the bikini piece inside the shroud pipe to ensure a tight fit. (Figs 1 – 11)

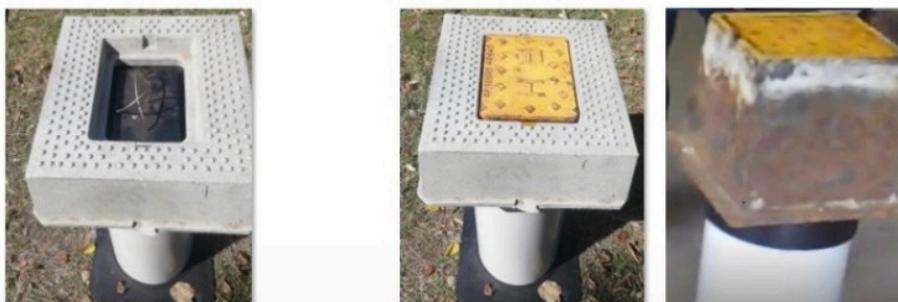
ANT AND DEBRIS BARRIER - INSTALLATION INSTRUCTIONS

FITMENT DURING HYDRANT REPLACEMENT USING BIKINI WITH PRE-CUT HOLES

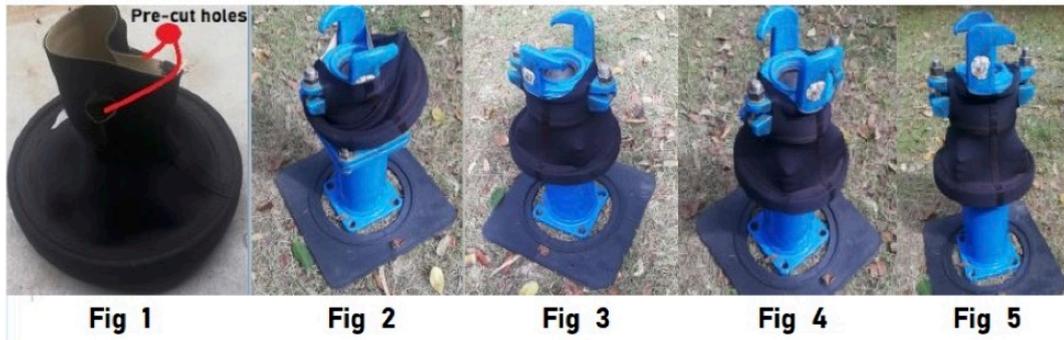
1. Line up the pre-cut holes in the bikini with the lug bolts. Push the bikini piece over the lugs one side at a time to expose the body-joint bolted connection through the pre-cut holes. (Fig 1, 2, 3, 4 & 5)

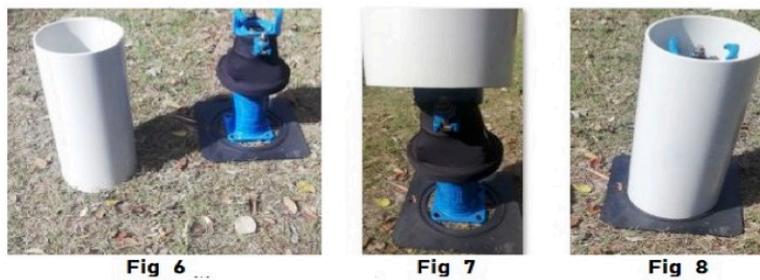
2. Push the DN 225 PVC shroud pipe over the hydrant and the bikini. Ensure the base of the bikini is tightly fitted inside the shroud pipe. Slide the pipe down to sit on the base plate. (Fig 6, 7 & 8)

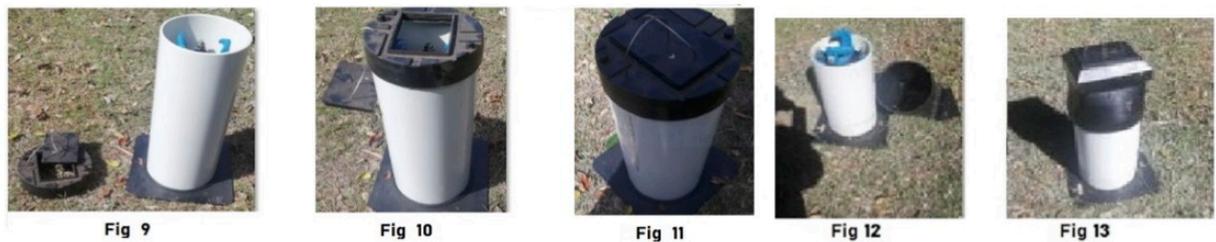
3. Fit the trafficable or non-trafficable cover and lid over the top of the shroud pipe ensuring a snug fit. (Fig 9, 10, 11, 12 & 13)

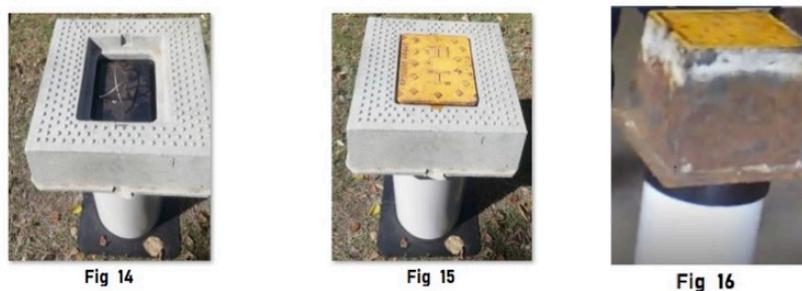
4. Re-install the surface cover. (Fig 14, 15 & 16)

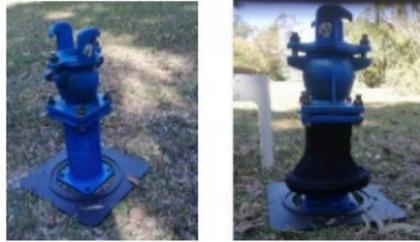
1. Push the bikini piece over the top of the hydrant assembly on to the riser.

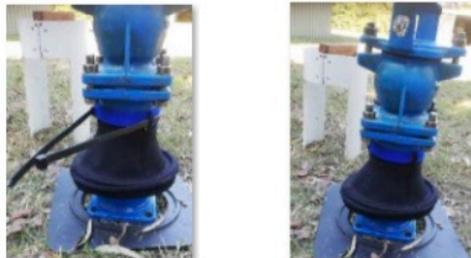
2. Fold down the top part of the bikini to expose the belt loops. Thread the zip tie through the loops. Keep the fold as close to the hydrant/riser flange as possible. Tighten the zip tie.

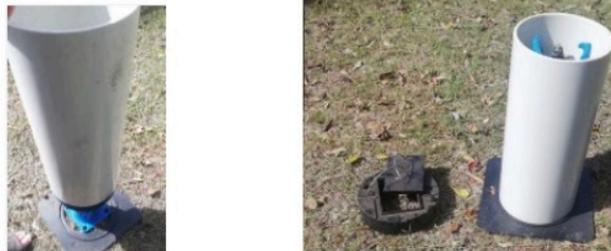
3. Slide the DN 225 PVC shroud pipe down over the hydrant and riser. When the pipe reaches the base of the bikini piece, tuck it into the bottom of the shroud pipe. Continue pushing the 225 PVC pipe down until it rests on the base plate.

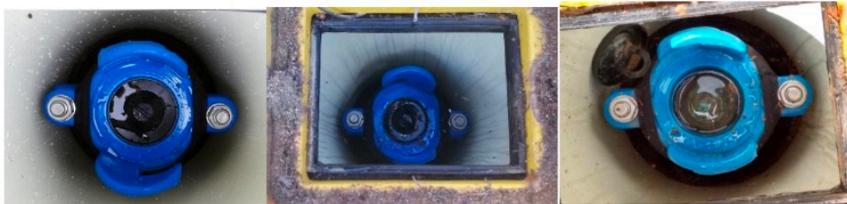
TARRIGINDI

There was no evidence of any soil or debris in the hydrant cavities. See photos below.

The Hydrant Services Pty Ltd Ant & Debris Barrier product was shown to be very effective in preventing the build-up of ants and debris around the hydrant.
