WATER SERVICES
ASSOCIATION OF AUSTRALIA

WSAA Materials Fact Sheet No. 05

Corrosion of Copper Pipe in Australian Drinking Waters

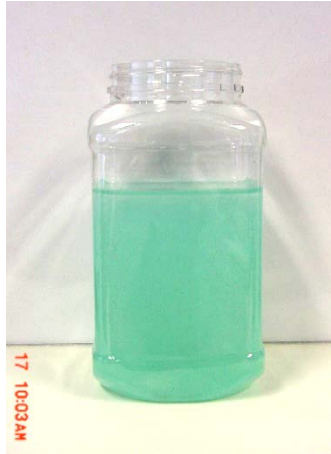
"Blue water", also described as "blue-green water" (BGW) is characterised by a blue-green colouration in the water when first drawn from a tap. The blue water is a result of a finely divided insoluble flocculent of copper corrosion products suspended in water. It is more frequently observed in pipes with patterns of low use. Often it will be visible when a tap is used after even a short period of stagnation.

Example of Blue Water

The colour of the water, which can vary from a pale blue through to dark green/blue, is characterised by settlement of the flocculent (particles) if the container is left to stand overnight. The type of corrosion products depend on the actual water composition, but are most likely to be copper hydroxides with some silicates and perhaps sulfates. Blue water is characterised by elevated levels of copper which often exceed the Australian Drinking Water Guidelines (ADWG) recommended limit of 2 mg/L. This limit is based on a lifetime consumption of water with this level of copper so only in rare circumstances does this represent a significant medical issue.

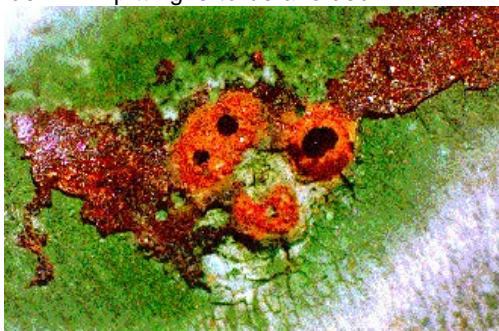
Cold water pitting corrosion is a far more destructive form of corrosion that often results in the perforation of the pipe wall with a corresponding leak. Pitting can share many attributes with ‘blue water’ and often, but not always, occurs in conjunction with it. Pitting was generally far less prevalent than ‘blue water’, but since the virtual elimination of the latter issue in municipal water supplies this is no longer the case. While pitting can also occur in hot water, it is most common in cold, soft waters of neutral to slightly alkaline pH. As with blue water, pitting in soft waters is recognised as a worldwide problem, which also occurs in a sporadic and random pattern, sometimes in clusters at the extremities of water distribution systems, which does tend to endorse the idea that both pitting and ‘blue water’ have a common cause through an association with MIC.

Internal pitting of copper pipe surface

As with blue water, avoidance can be accomplished by increasing the buffering capacity of the water through calcium bicarbonate additions, and this measure has

been practiced both in Australia and overseas for some time. The actual benefits are hard to quantify. The average time to perforation of an actively pitting pipe is 11 years, and can be as long as 25 years – or as short as one year. Nevertheless, increasing the buffering capacity is at least partially effective and represents one of very few bulk water treatment options available.

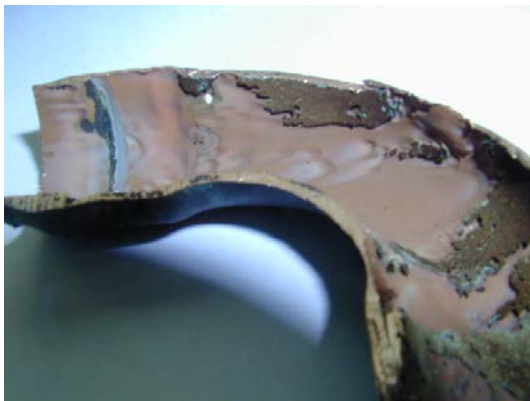
Erosion-corrosion is a rare form of failure that can occur in both hot and cold copper water pipes, although it is more often observed in hot waters. Erosion-corrosion can be identified by the presence of smooth grooves, gullies, waves or rounded holes on the inside of the pipe that usually exhibit a directional pattern. Often there are horseshoe shaped pits with the closed ends facing upstream. Failure can occur relatively quickly.

Typical erosion-corrosion of copper pipe

- Piping design—excessive velocity can cause erosion-corrosion. Pipes and pumps should be sized to ensure water velocity does not exceed 3 m/s, although for recirculating hot water systems (RHWS) it should be less than 1 metre/second. Sharp changes in direction, burrs inside joints and dents in the wall can contribute to this type of corrosion.
- Temperature. In RHWS temperatures should be less than 65°C. Note that in Australia, there is a tendency to run RHWS very hot in relation to the

- Dissolved gases— entrained air and high levels of carbon dioxide in the water can cause erosion-corrosion as they continually break down the normal protective films formed inside copper pipes. A similar process can occur if air is drawn into water through pumps and valves.
- Particulate matter—sand, grit or other debris carried in copper pipe can also break down protective films.
