North East Victoria & Gippsland Bushfire Rapid Risk Assessment Team report from the 2013 Alpine fires

2013 Alpine Fires

North East Victoria & Gippsland

RISK IDENTIFICATION

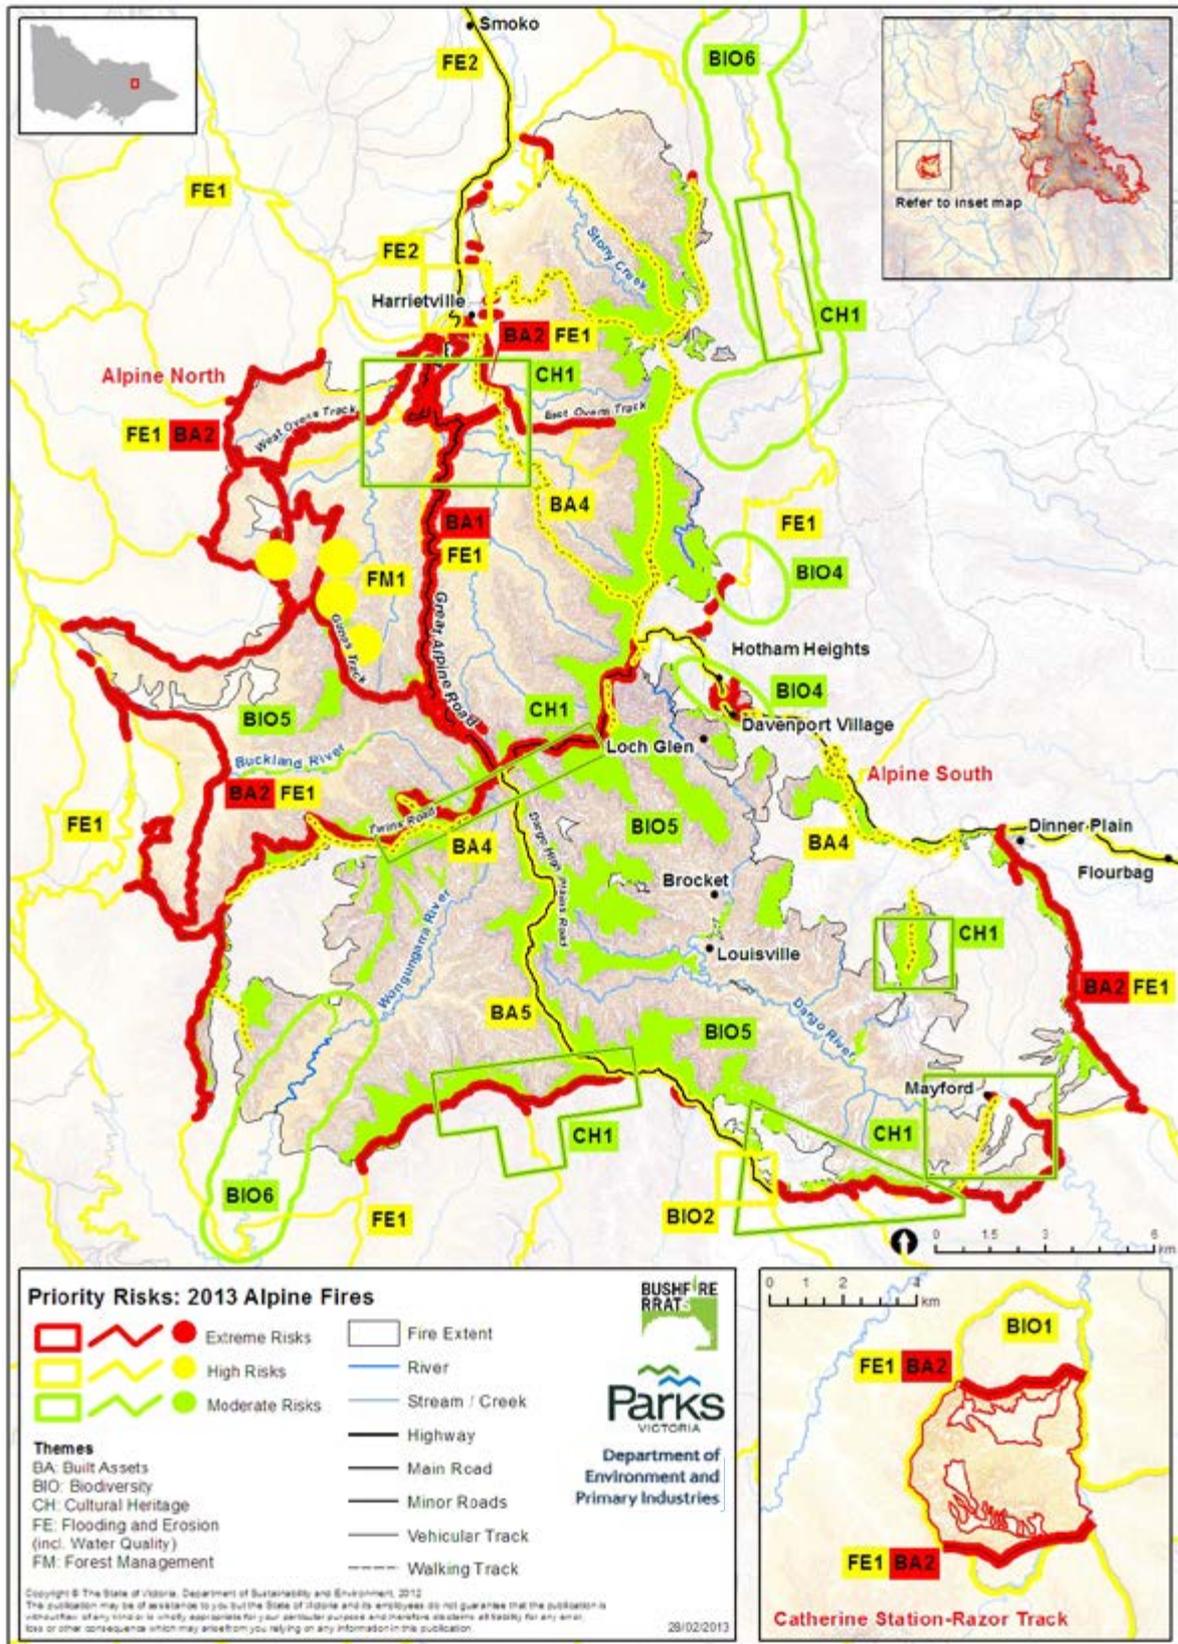
Figure 3 – Priority Risks

See *Figure 3– Priority risks*, Page 7, for the location of most of the priority risks (some cannot be represented at this scale). The ‘Risk ID’ refers to the unique identifier in the first column of Table 1, pages 8 and 9, and the relevant discipline section. The risks on the map are colour coded as extreme (red), high (yellow) and moderate (green). These represents the priority risks identified during this Bushfire RRAT deployment.

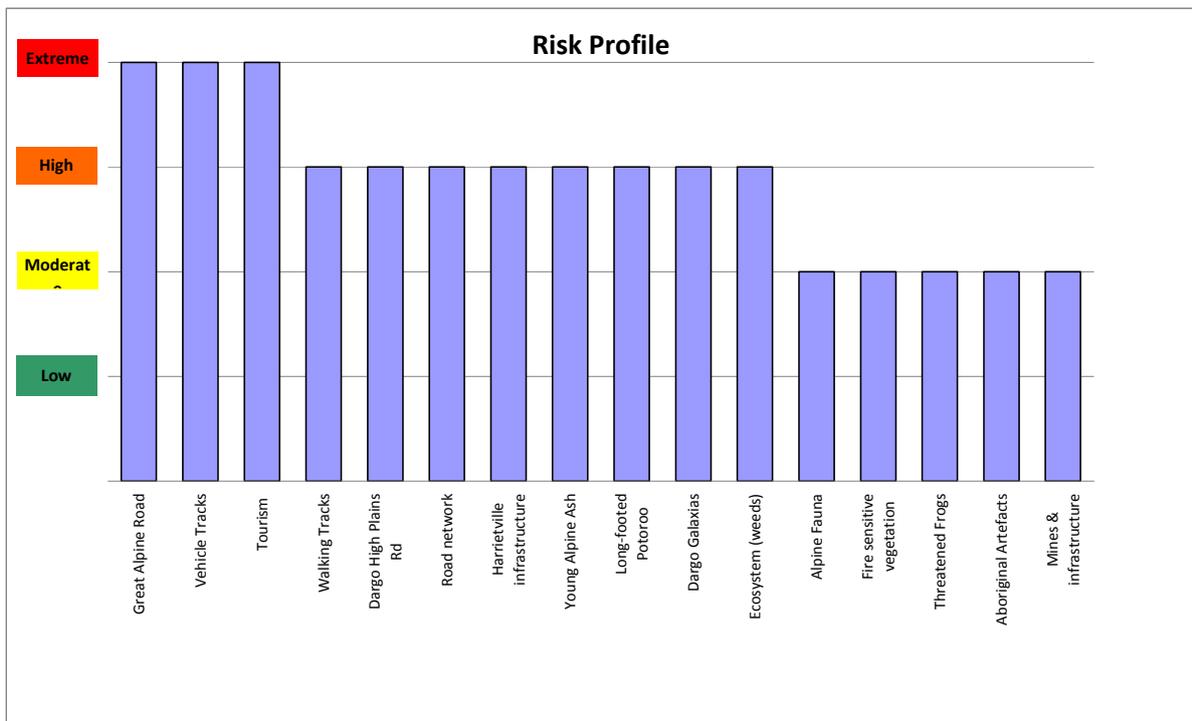
Figure 4 – Risks identified and assessed

Each risk assessed is represented by a bar, and the height of the bar indicates the risk (a combination of consequence and likelihood). The risk analysis, and component likelihood and consequence ratings follow the standards in DEPI's Risk Management Guidelines (2012).

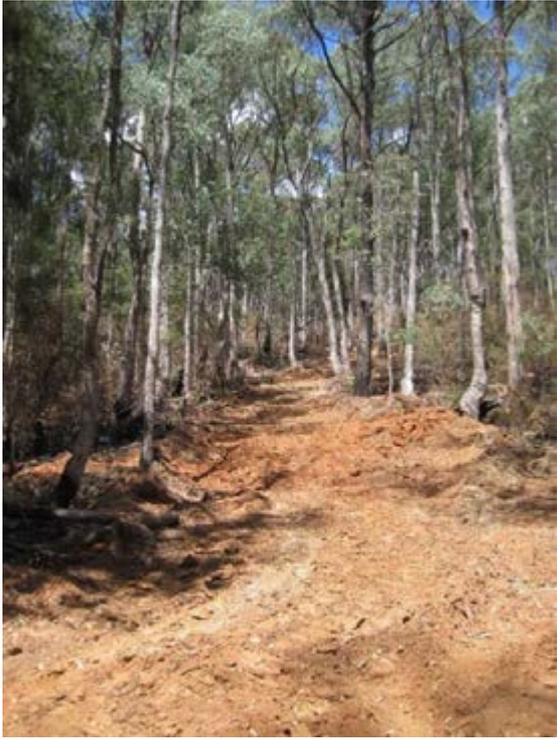
<p><i>Containment line constructed through previously undisturbed land. Note lack of structured drainage and high susceptibility to erosion.</i></p> <p><i>Buckland Sector</i></p> <p><i>Photo: Charlie Showers 25 February 2013</i></p>

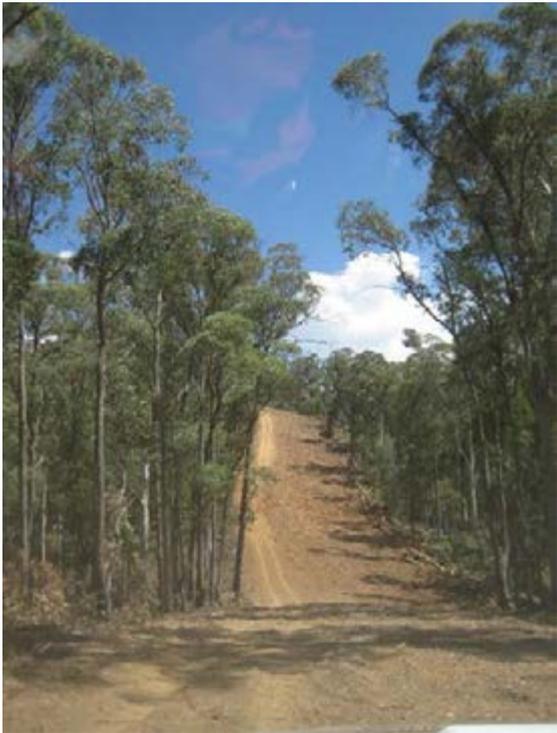
<p><i>Existing track used as a containment line with native vegetation cleared within 30m on the left hand side.</i></p> <p><i>Photo: Charlie Showers 25 February 2013</i></p>

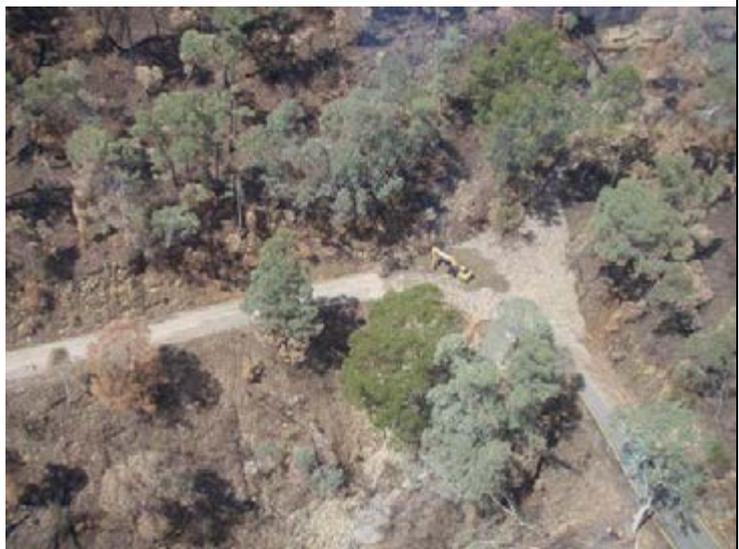
Debris flow that occurred across the Great Alpine Road, on 27th February 2013. This photo shows the Great Alpine Road being cleared of rubble just above the Sambas Mine, approx 4km from Harrietville.

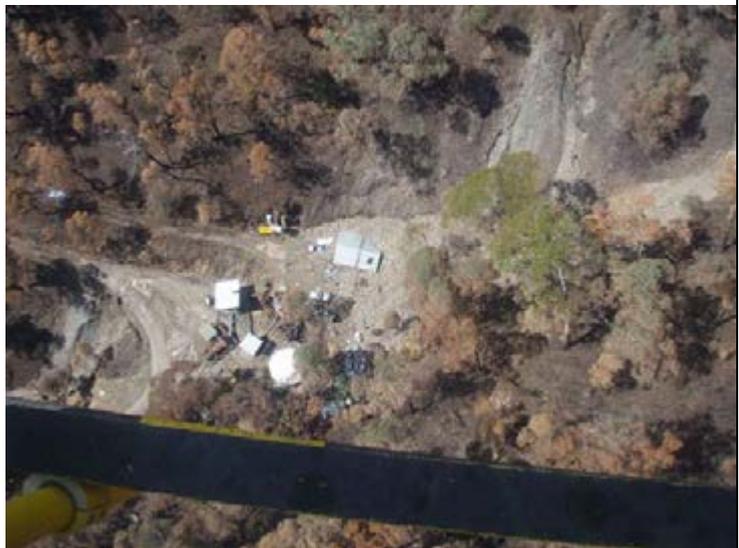
Debris flow that occurred across the Great Alpine Road, on 27th February 2013. This photo shows the impact on the Sambas Mine, with the partial burial of a mine building and complete burial of machinery. Approx 4km from Harrietville.

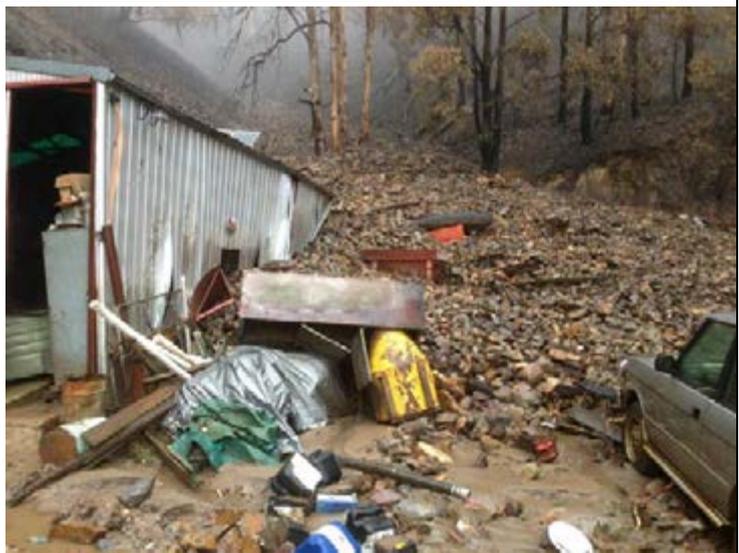
Debris flow that occurred across the Great Alpine Road, on 27th February 2013. This photo shows the impact on Sambas Mine infrastructure.

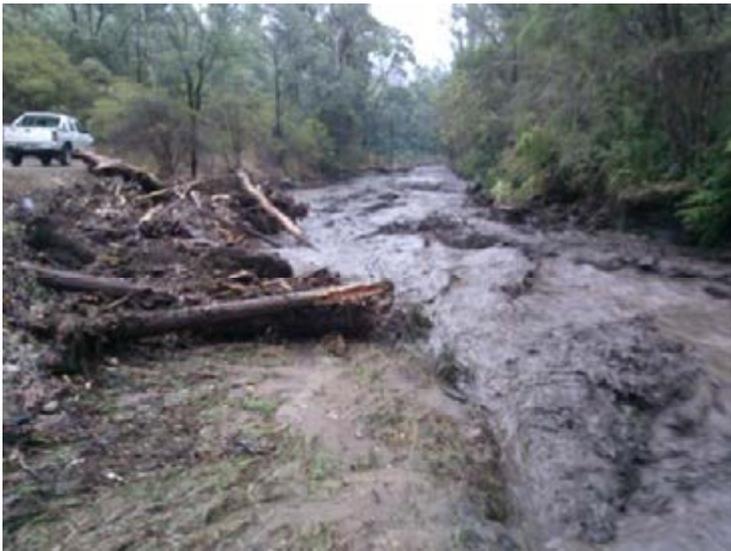
<p><i>The East Ovens tributary which has its catchment area in the alpine and sub alpine areas below the Razorback Ridge was severely burned. This shot is taken from North East Water's offtake point for Harrietville's town supply. This rainfall event resulted in water being carted for Harrietville town supply and degraded water quality in the Ovens River at Bright to the point where groundwater was used to augment their domestic water supply.</i></p> <p><i>Photo: Charlie Showers 27 February 2013</i></p>

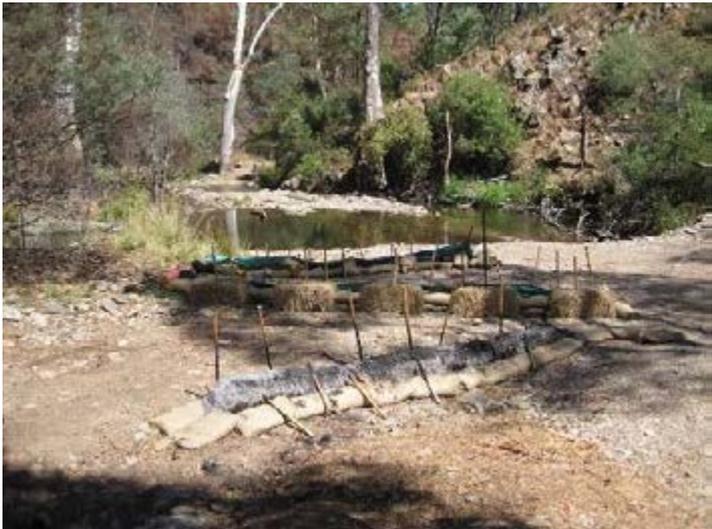
<p><i>Sediment traps on the Champion Track Spur Track in the East Ovens tributary.</i></p> <p><i>Photo: Charlie Showers 25 February 2013</i></p>

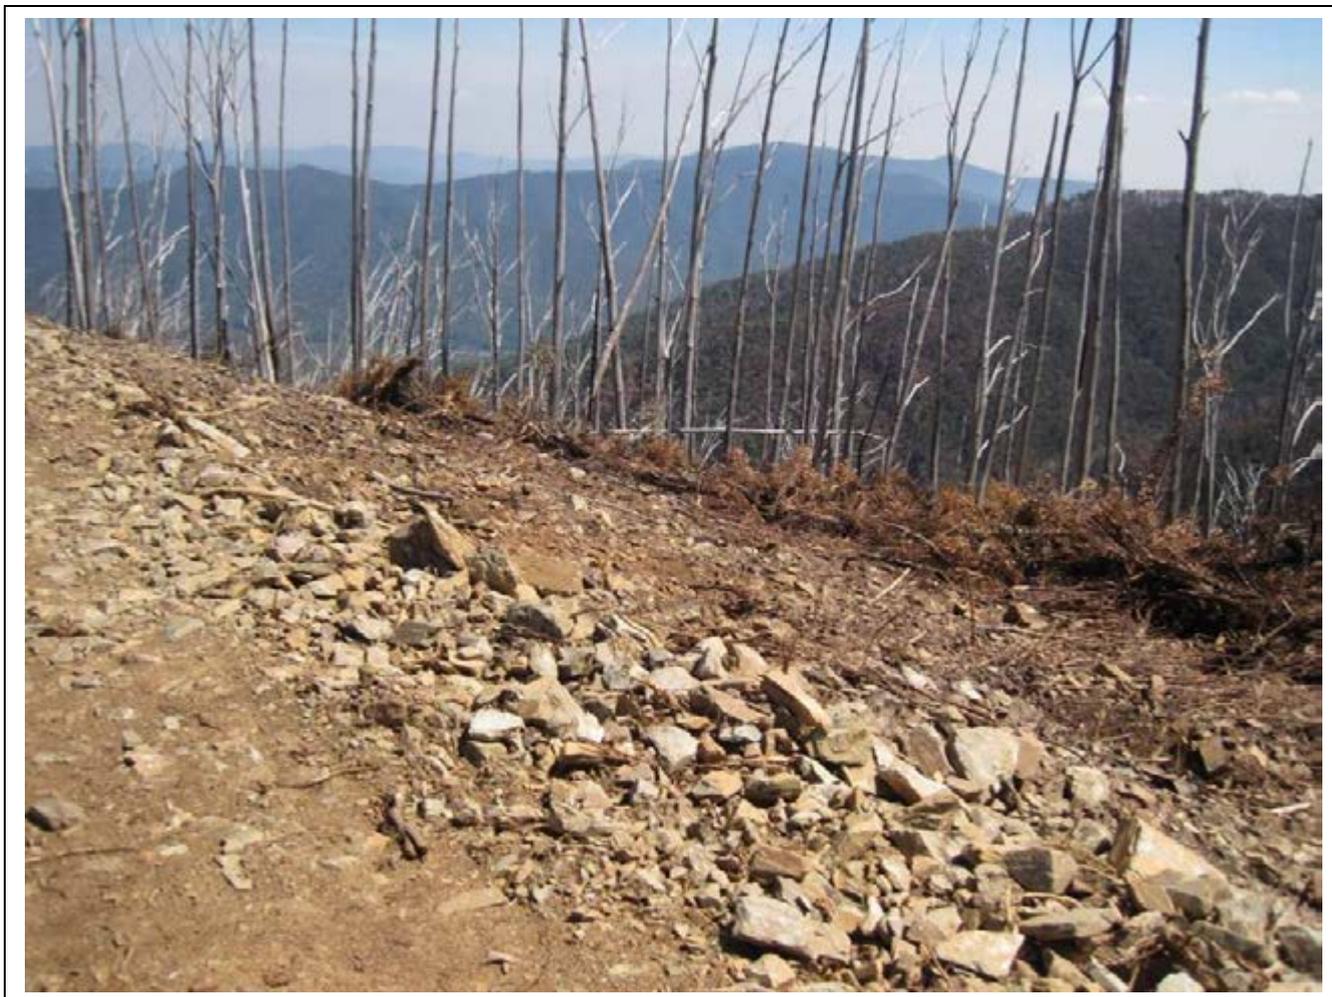
Appendix 5.2 Photograph of hazardous trees

Hazardous Trees along vehicle tracks. Photo Sue Berwick 26 February 2013

Hazardous trees present an extreme risk to public safety on the Great Alpine Road, Dargo High Plains Road, vehicle tracks and walking tracks within the fire area. The Great Alpine Road is a major thoroughfare from North East Victoria to Gippsland. These trees will need to be treated in accordance with current departmental hazardous tree policies and guidelines. Public firewood

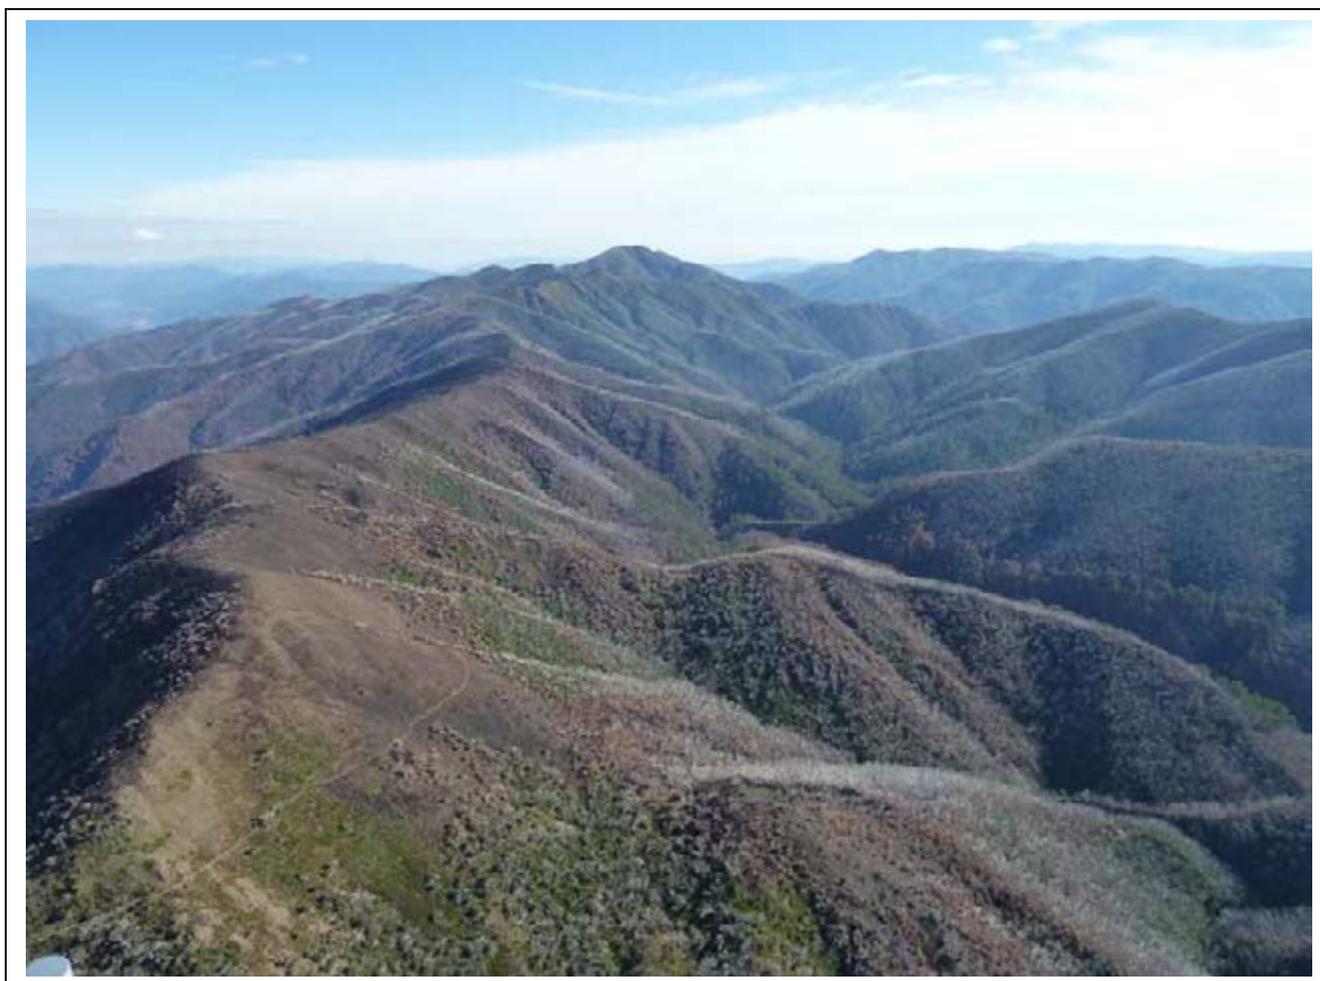
Appendix 5.3 Photograph of walking tracks burnt

Razorback Walking Track – route of track exposed, with potential for lack of definition. Track definition works required. Photo: Sue Berwick, 26 February 2013.

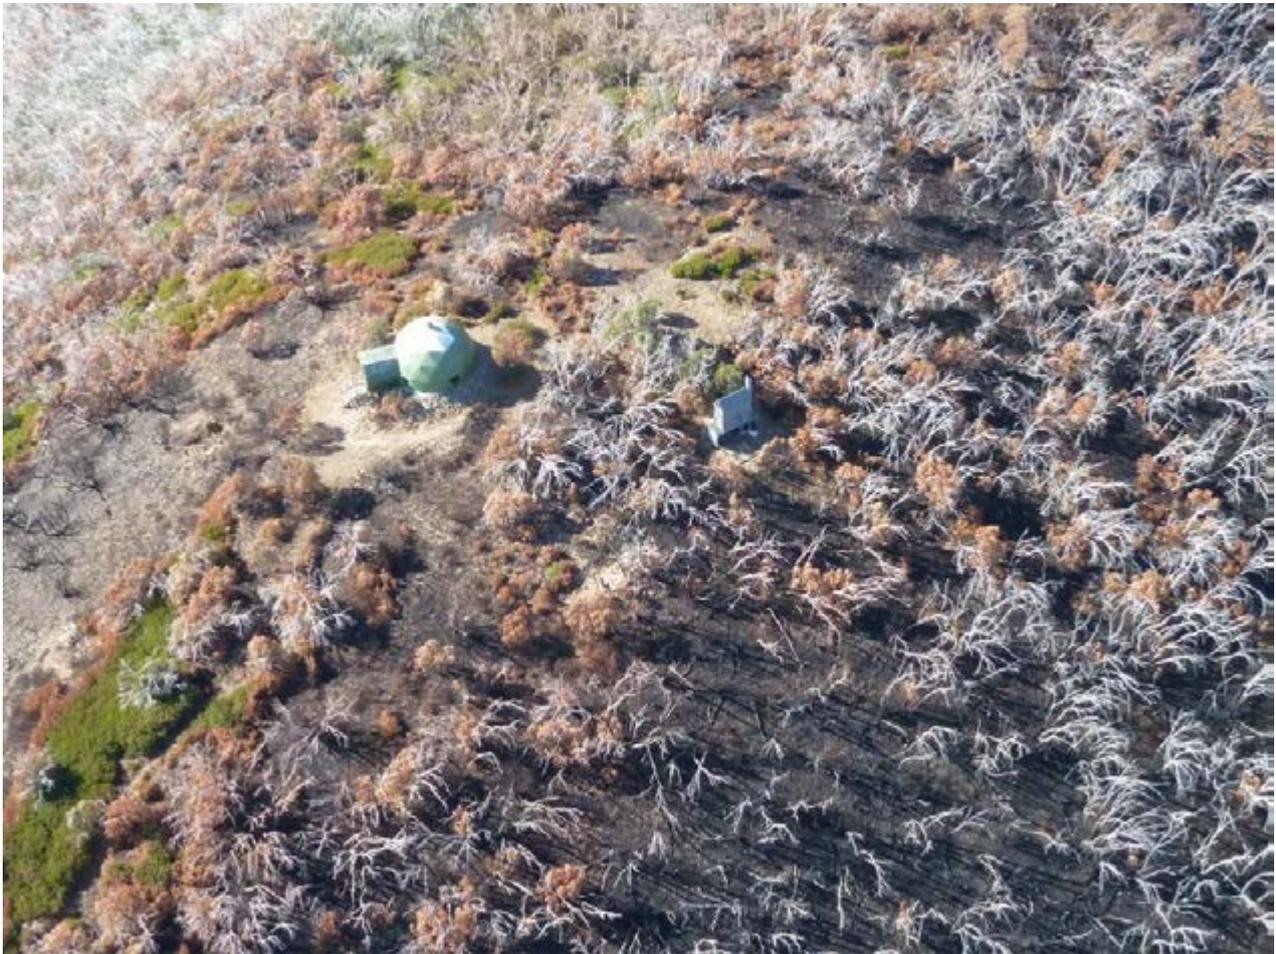
Appendix 5.4 Photograph of infrastructure assets

*MUMC Hut and toilet – damage to signage in the vicinity and steps of toilet.
Photo: Sue Berwick, 26 February 2013.*

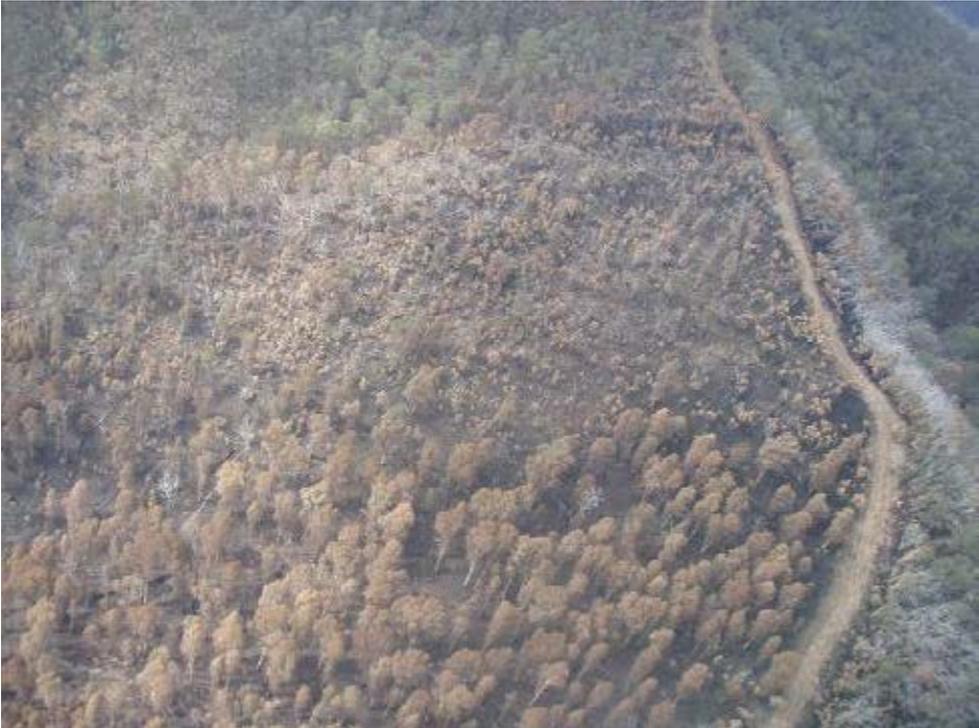
Waypoint / description	FM photographs
<p><i>Fire killed Alpine Ash 2007 regrowth (FM1)</i></p> <p><i>Photo: Sue Berwick, 26 February 2013</i></p>

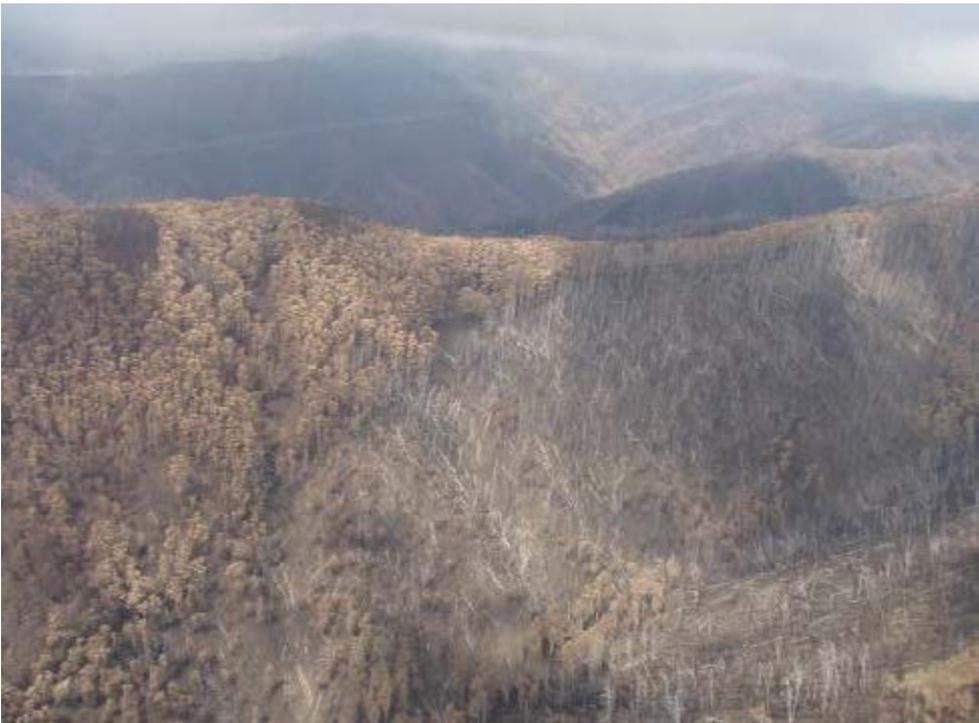
<p><i>Fire killed Alpine Ash (FM2)</i></p> <p><i>Photo: Sue Berwick, 26 February 2013</i></p>

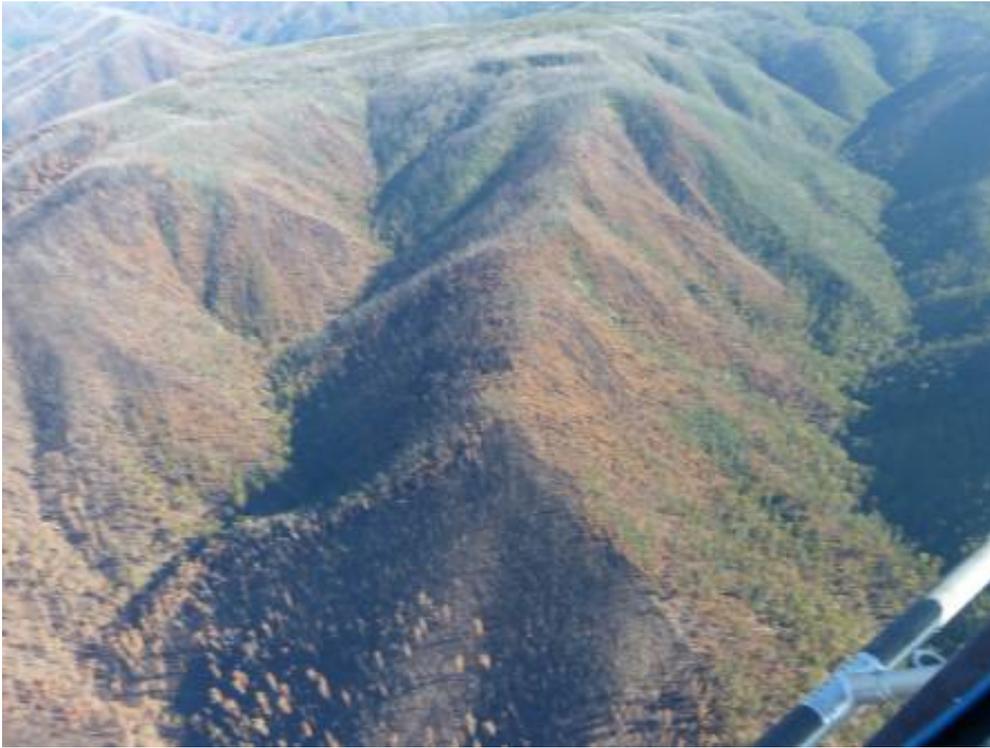
Waypoint / description	FM photographs
<p><i>Fire killed Alpine Ash and Snow Gums (FM1) Dargo Creek Area</i></p> <p><i>Photo: Sue Berwick, 26 February 2013</i></p>

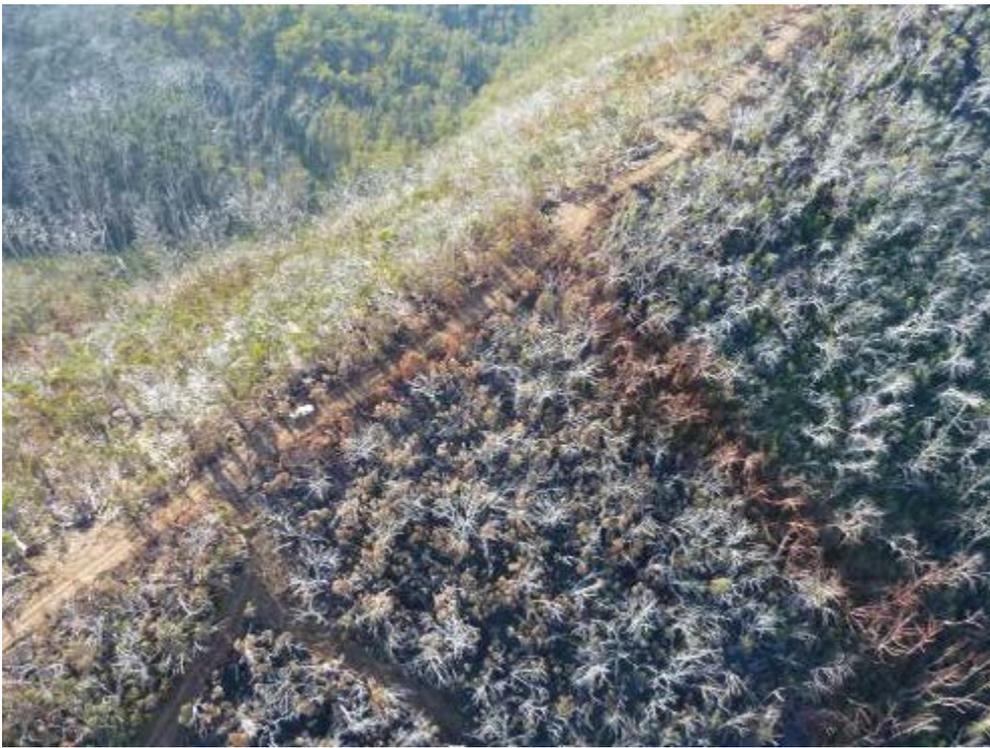
<p><i>Fire killed Snow Gums (FM1), Blue Rag Range area</i></p> <p><i>Photo: Sue Berwick, 26 February 2013</i></p>
