MANAGING DEBRIS FLOW RISK IN CATCHMENTS AFTER BUSHFIRES

Following a fire in the Thomson Reservoir catchment in January 2019, Melbourne Water needed to manage the incident to reduce the likelihood of ash and fire debris contaminating the water supply which could cause a reduction in chlorine efficiency, aesthetic degradation and an inability to supply water.

This is one of two case studies from Melbourne Water about recovery from the Thomson Reservoir catchment bushfires and provides an understanding of mitigation works installed by Melbourne Water in the catchment and reservoir to address debris flow risk.

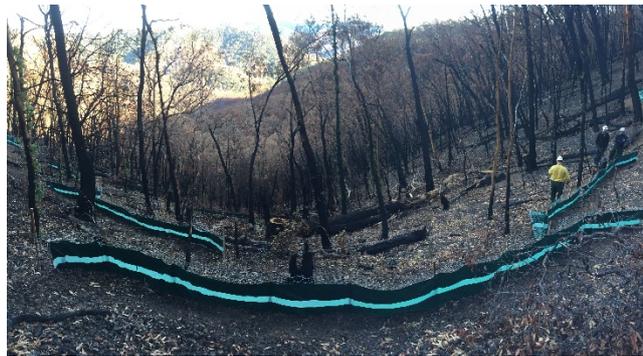
Sediment fences installed in high-risk bushfire affected headwaters (Gary Sheridan, The University of Melbourne).

Sediment barriers

- Reduce the amount of debris reaching the reservoir
- Reduce force of flow and therefore reduce downslope scouring.

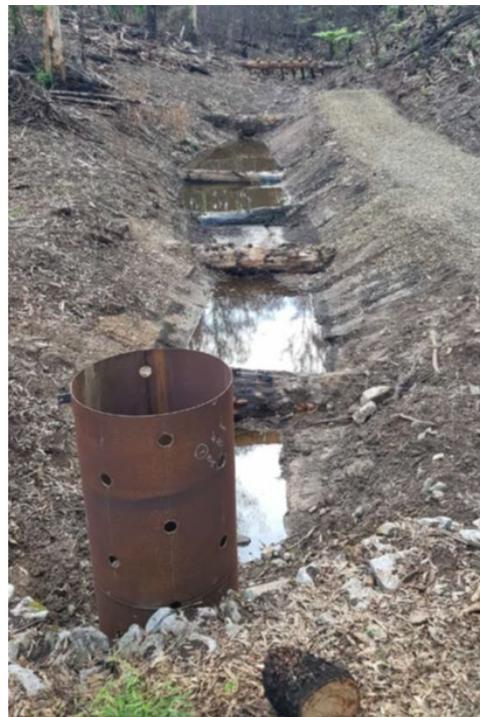
Debris racks and sediment dams (Melbourne Water).

Debris racks and sediment dams

- Coarse sediment and debris caught upstream of culvert
- Fine sediment will settle around the riser.
