Appendix E

Melbourne Water's experience with the application of debris racks and sediment dams

MANAGING DEBRIS FLOW RISK IN CATCHMENTS AFTER BUSHFIRES

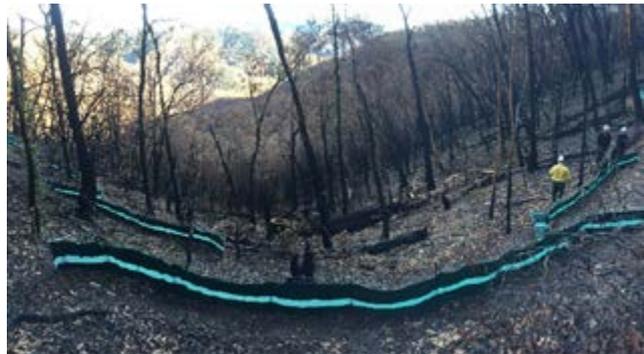
Sediment fences installed in high-risk bushfire affected headwaters (Gary Sheridan, The University of Melbourne).

Sediment barriers

- Reduce the amount of debris reaching the reservoir
- Reduce force of flow and therefore reduce downslope scouring.

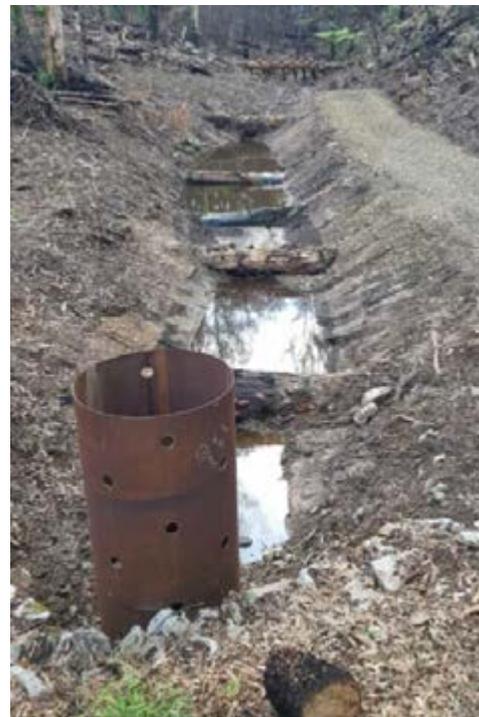
Debris racks and sediment dams (Melbourne Water).

Debris racks and sediment dams

- Coarse sediment and debris caught upstream of culvert
- Fine sediment will settle around the riser.
